A FarMedia “Lab and Listen™” Report

Project: “Audiophile Modified” Scott 370 tuner evaluation
 Client: (Name Removed by Request)

1 Introduction: About this project

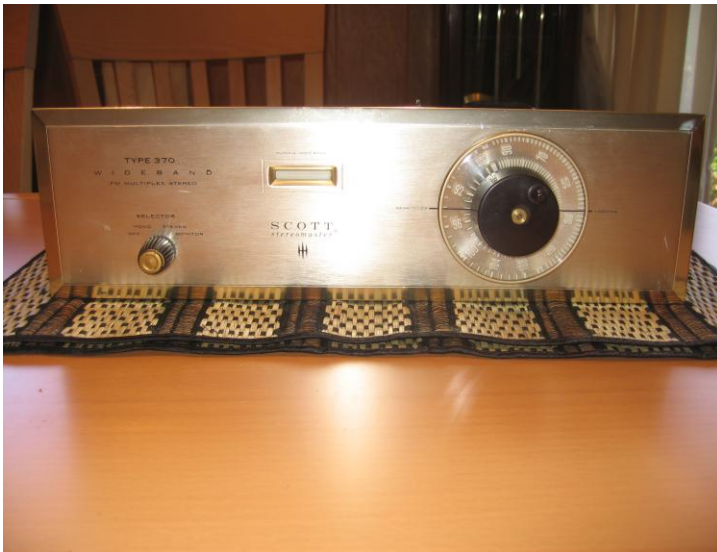
3.1 Audiophile modified tuner, front panel

There are no modifications or visible changes to the front panel.

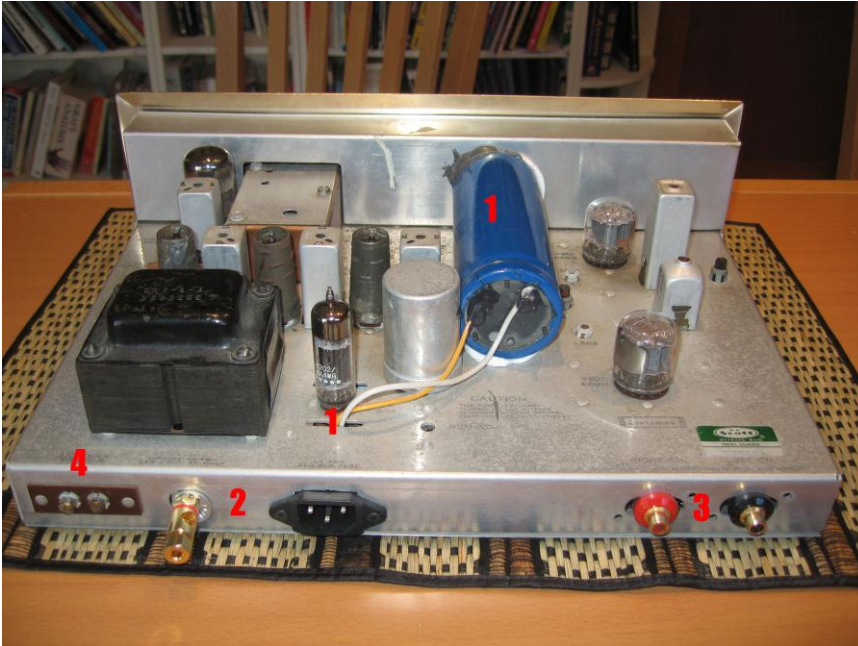
3.1.3 Audiophile modified tuner, back panel and chassis top view

Visible changes to the back include:

1. A large capacitor epoxied to the top deck, with value obscured.
I prefer to see these large capacitors attached via mounting clamps, as it is then both secure and removable. The capacitor is epoxied to the front metal "doghouse" making it impossible to remove and service the tuning eye tube. The leads are dressed through a cooling slot, but there isn't a grommet or anything to prevent the metal from chafing through the wire insulation. A potential problem is the inrush current of this capacitor is much higher than the power supply was designed for, which may lead to premature rectifier or transformer failure. Finally, the capacitor appears to be a photoflash unit. These capacitors are designed for intermittent use and not recommended for continuous duty filter applications.

2. Removal of the standard AC cord and alarmingly, the fuse. (More on this later.) The fuse hole was enlarged to accommodate a chassis mount IEC style power jack, and the AC cord hole was repurposed to fit a large ground post.
 3. Replacement of the standard RCA phono jacks with a pair of audiophile grade gold ones.
 4. Curiously, the 300 ohm antenna connections are not supplemented with either a chassis mount F connector or a 300 to 75 ohm matching balun. Considering the audiophile focus, this seems odd.
- It appears all the tubes have been replaced, aside from perhaps the tuning eye. (See the comment on the large capacitor previously.) The tubes in the boxes are mostly Scott labeled.

1. The jack retrofits are somewhat crudely done, although they appear to be serviceable. The audio and ground post connections use washers to help fill the holes enough to mount the part. I would have preferred to see small plates filling the cut-outs, and proper sized holes drilled in the filler plates, but I'm a bit of a neatnik.
2. The capacitor epoxied to the top deck on the audiophile modified tuner makes servicing the unit difficult, as the doghouse can no longer be removed to access the tuning eye and the tuning mechanism.

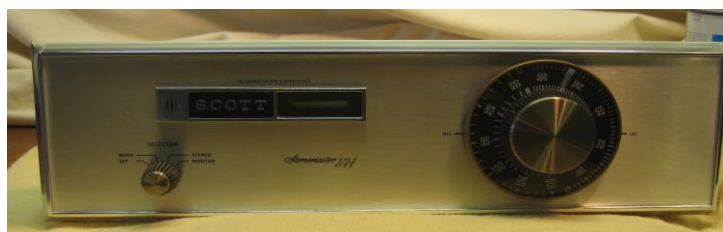
3.2 **Stock tuner, front view**

Front of stock tuner.

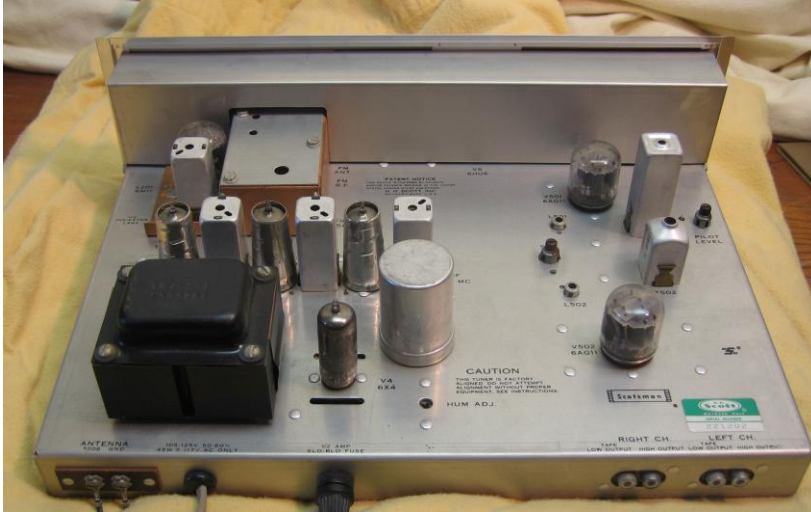
3.3 **Stock tuner, back view**

My tuner is a 370-B, with the later faceplate and knob cosmetics; the production electronics between the tuners are identical. I believe all the tubes in the stock tuner are originals

Back and chassis top view of stock tuner

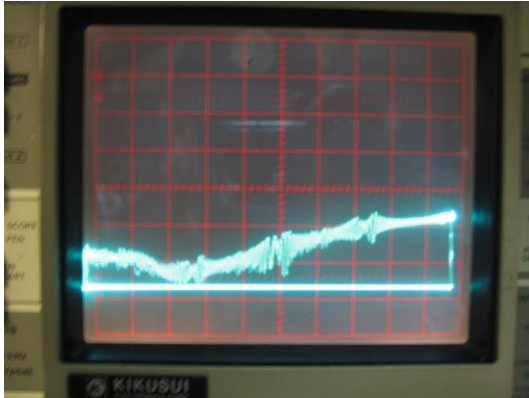
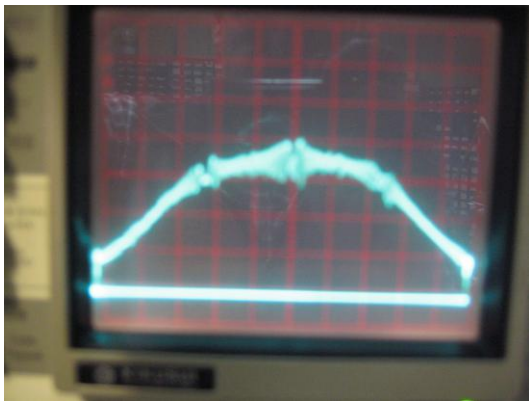
6.2 IF alignment and detector

Audiophile modified tuner – (poor IF pattern)

Stock tuner – (correct IF pattern)

The audiophile modified tuner had a rather misaligned IF stage, indicative of “by ear” tweaking. A few iterations through the IF section cleaned up the response to look like the stock tuner IF response on the right.

1. The audiophile modified tuner stereo distortion was over 10% when I started. It dropped to about 6% after inserting a low pass filter and the mono THD dropped to about 1.5% after careful adjusting. This is still higher than I usually see in a Scott, but it matched the stock tuner in this regard. Perhaps the generally higher THD is due to the narrower bandwidth detector design used in the 370's.
2. As mentioned, previously, I had to use an A weighting filter to remove the extra ultrasonic noise from the output in order to adjust the detector, so the absolute numbers are somewhat problematic.

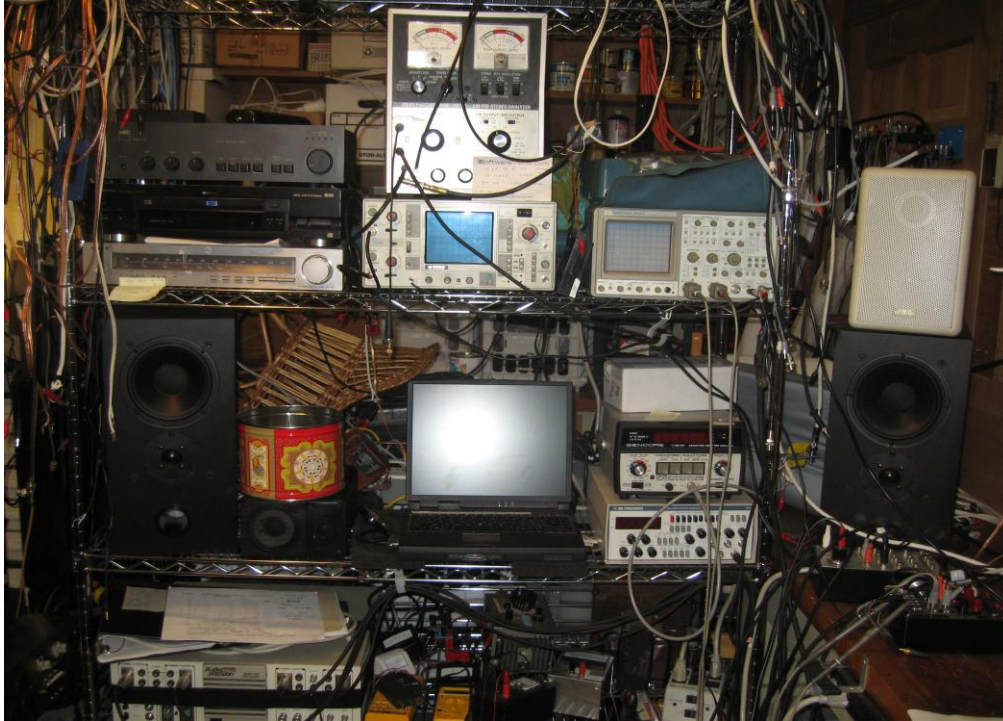
FarMedia is my company for doing sound related business. I'm quite proud of the test equipment roster, as it represents a nice test and analysis suite for audio equipment, both modern and vintage. Here's a shot of the main equipment rack, festooned with the usual cables.

4. The crown jewel: An Audio Precision System One, Dual Domain, model 322 with options for A & C weighting filters. The "AP" is *the* industry standard for audio measurements, and is NIST traceable. Using a computer interface, it can measure and log frequency response, THD, S/N, power bandwidth, RIAA phono and FM eq accuracy, noise spectrums, IMD, and much, much more. It's the boring looking beige box at lower left, and is driven by the notebook computer in the center.
